HOUSE CHECK HOME INSPECTION LLC

Confidential Property Inspection Report

INSPECTION ADDRESS: 123 Main Street
Monmouth, New Jersey

Property Inspection Date: 01/01/2020

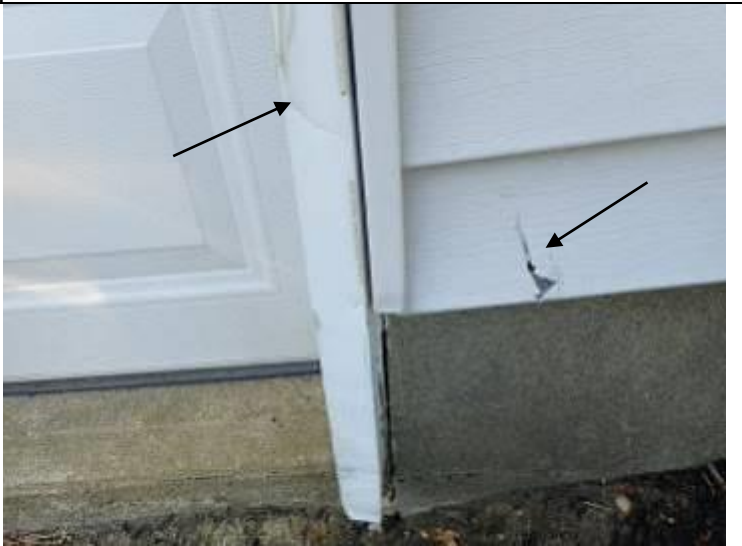
Damaged vinyl siding along garage. Also dented garage door jamb aluminum capping.

Exterior wood requires either capping or regular painting. Caulking and sealing is recommended to prevent water seepage. Replace wood trim where moisture damaged like that noted below the rear entry door. Replace runs of damaged and cracked vinyl siding. Repair dented capping as noted around the garage jambs.

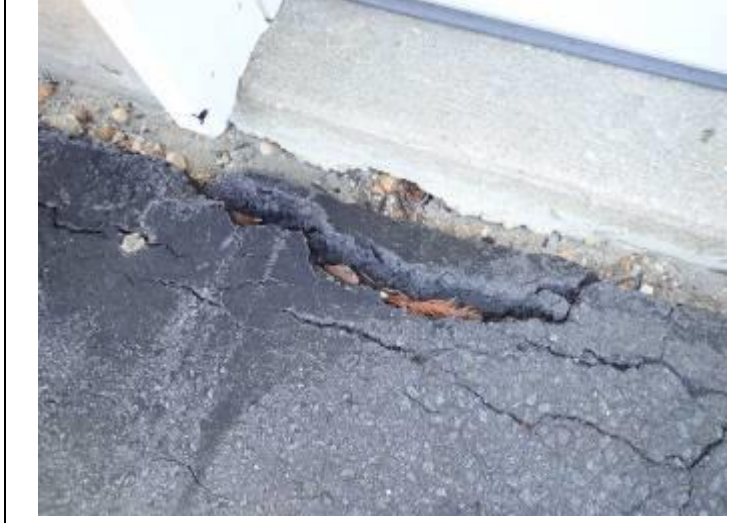
Damaged asphalt driveway adjacent to garage.

Any change of elevation 1/4 of an inch or more is considered a trip hazard and should be corrected. Keep pavers in walkways level and secure for safety. Repair/replace cracked slate in the rear walkway. Repair the deteriorated asphalt driveway and seal for extended useful life. Seal cracks at the front sidewalk.

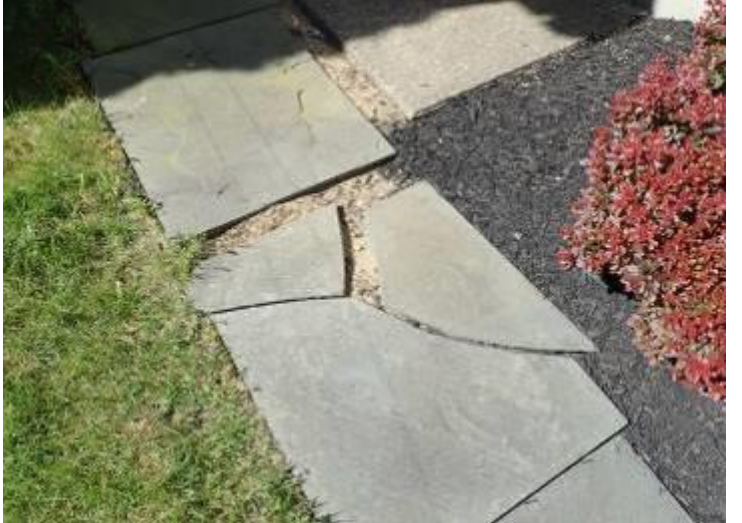
Cracked slate at rear walkway.

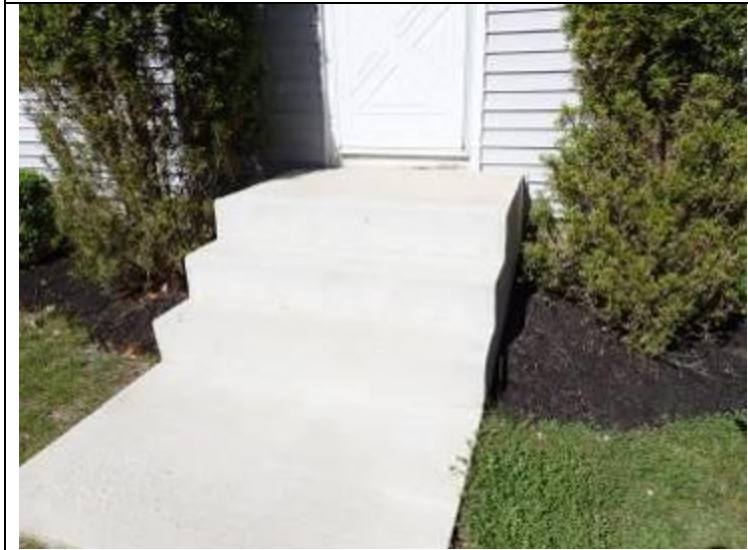
We advise continuous graspable handrails at all steps of 3 or more risers.

We advise handrails at the rear entry steps. We note some cracking at the rear patio block wall. We advise sealing and monitoring. Repair cracked concrete treads in steps. We note staining in the rear enclosed porch. The rear yard concrete patio is deteriorated.

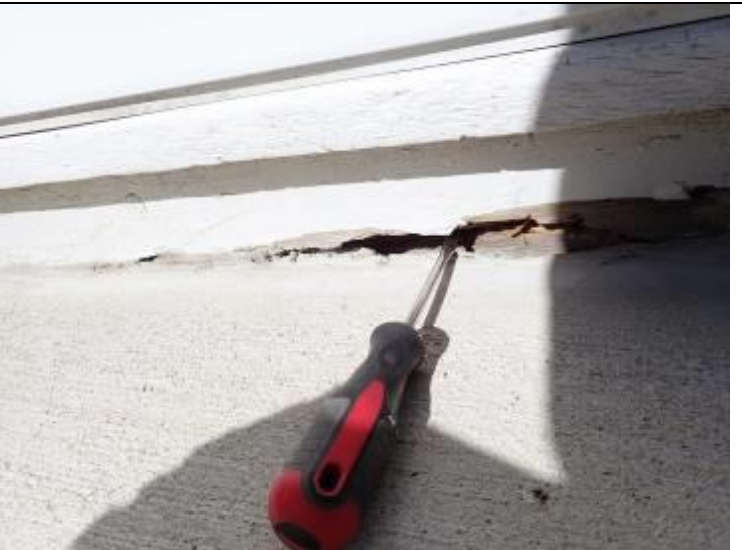
Moisture damaged bottom trim at rear entry door.

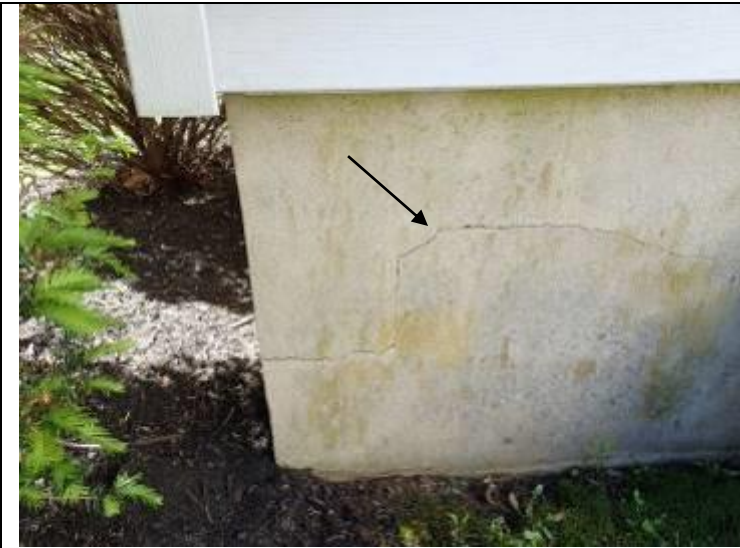
Some cracks are noted at the parge coating along the rear enclosed patio.

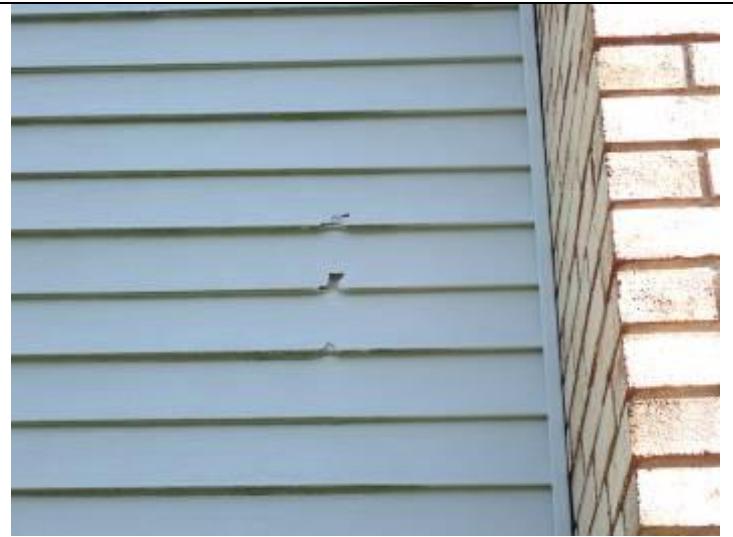
Some damaged vinyl siding along the right side of home.

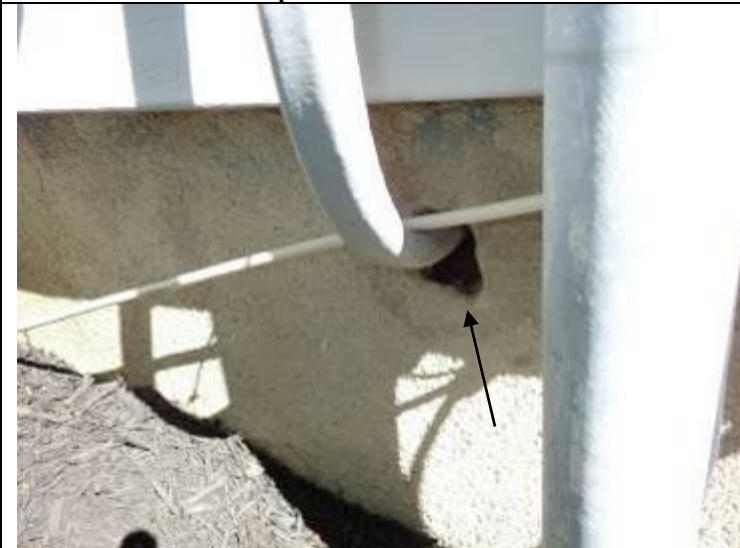
Seal opening in foundation wall for the electric cable to prevent moisture and vermin entry.

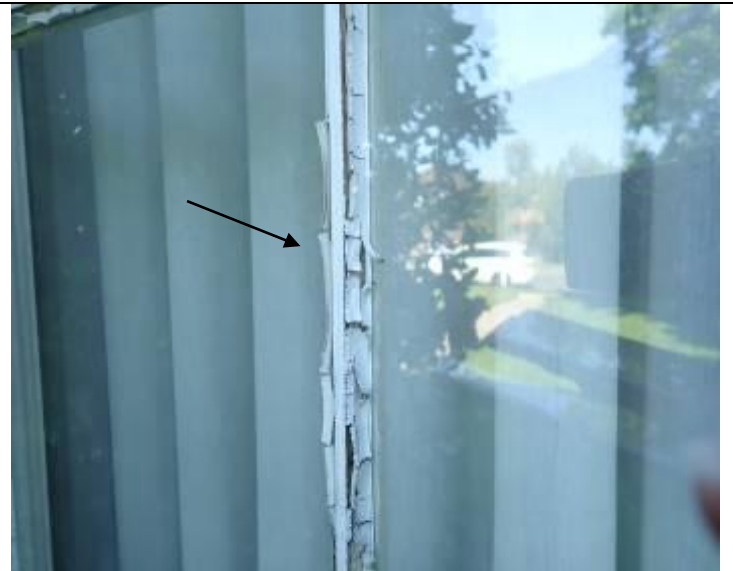
Deteriorated glazing putty on single paned windows.

Replace areas of deteriorated glazing putty on single paned windows. Replace the cracked storm window at the upper front of the home. Install screens where missing and repair where damaged. We advise glass in doors be safety rated.

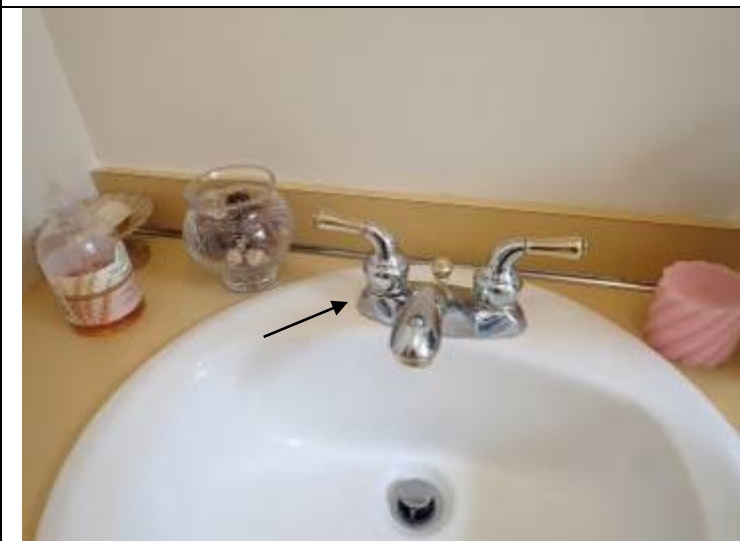
Loose faucet at the 1/2 bathroom sink.

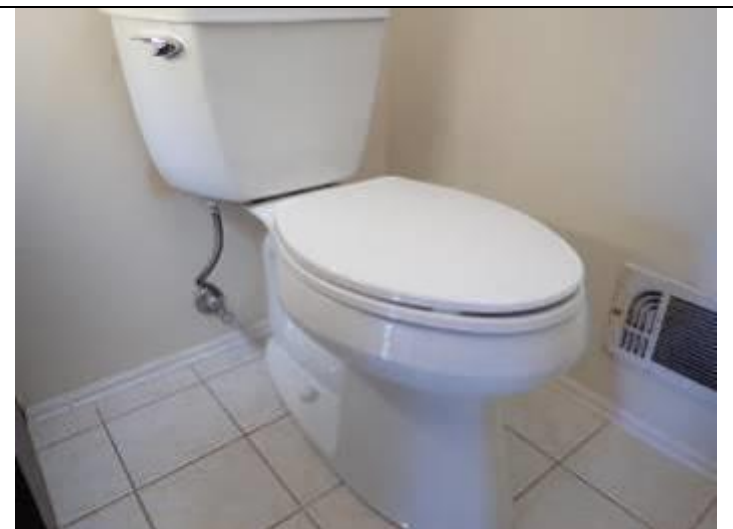
Loose toilet at 1/2 bathroom.

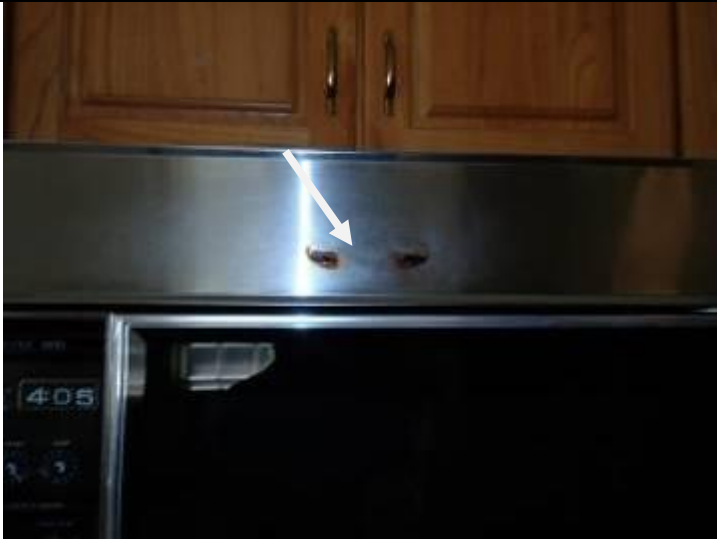
Damaged handle at the oven vent.

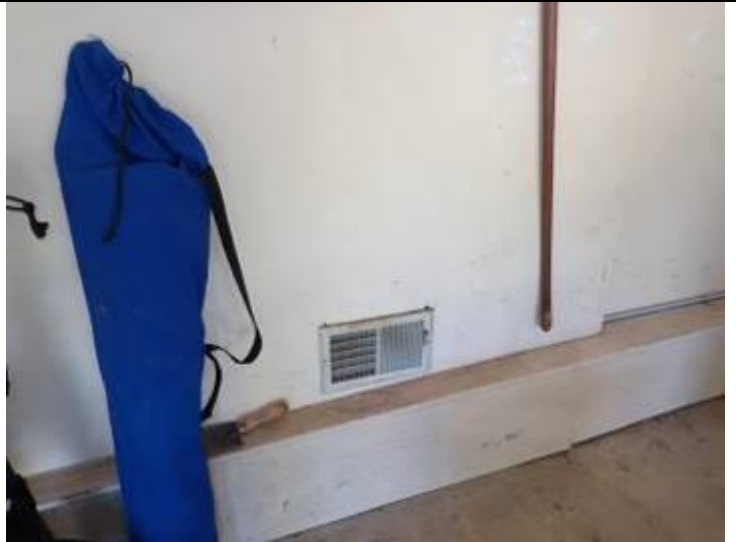
We do not advise vents in garages.

We advise auto reversal sensors for the automatic garage door opener be set between 4-6 inches off the ground for optimal safety. We do not advise vents in garages. They can introduce the potential of noxious gas in the garage being drawn into the living space. We advise a handrail for the garage to house steps. We note damage to the foundation wall at the front of the garage. We note termite damage to sheetrock along the inside garage wall. There may be hidden damage in the wall. Stained walls and ceiling is noted. Further investigation would be needed to determine this.

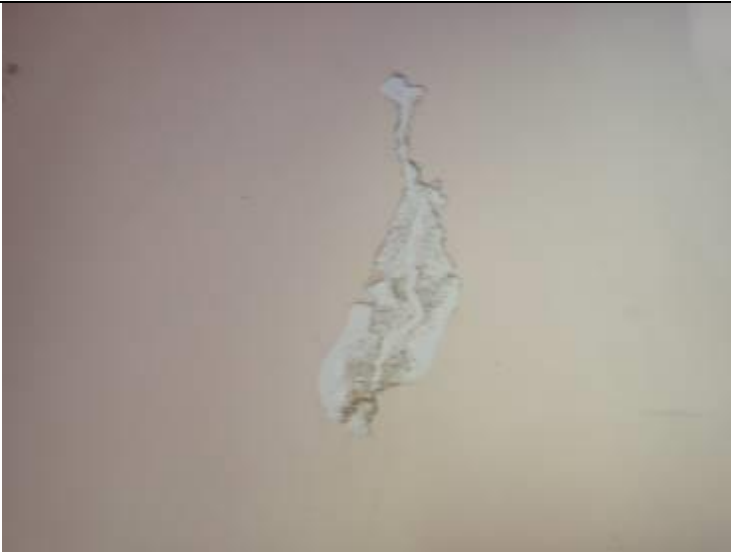
Termite scarring at sheetrock on garage wall.

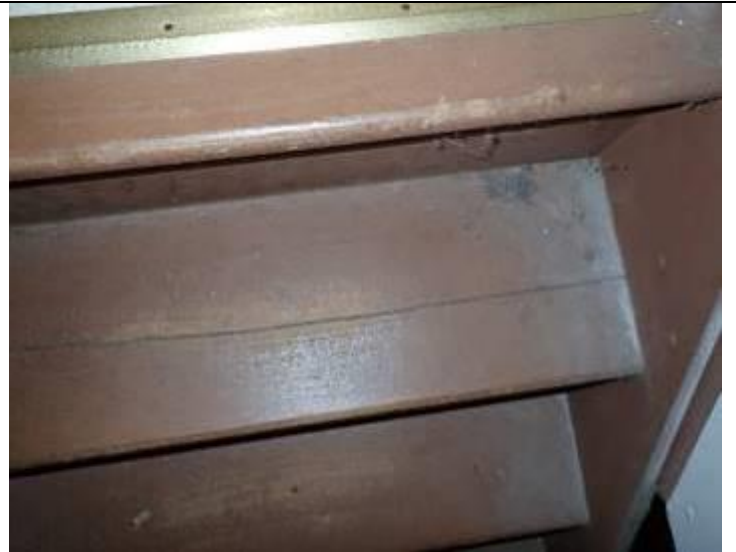
Cracked basement stair tread.

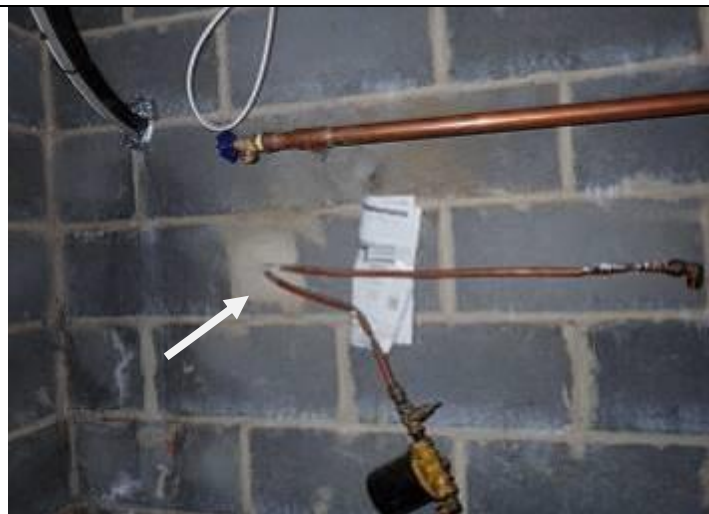
Copper lines in basement wall are an indication of a buried oil tank

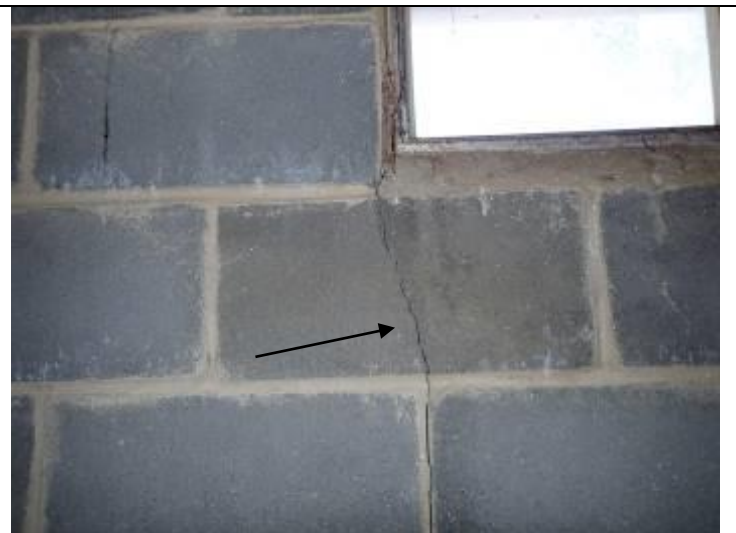
Vertical crack along right side basement wall.

Seal penetrations like that noted at the a/c refrigerant lines in the foundation wall to prevent vermin entry. We note some vertical and horizontal cracks at the foundation wall in the basement. Have these evaluated by a foundation mason/ structural engineer for any needed repairs.

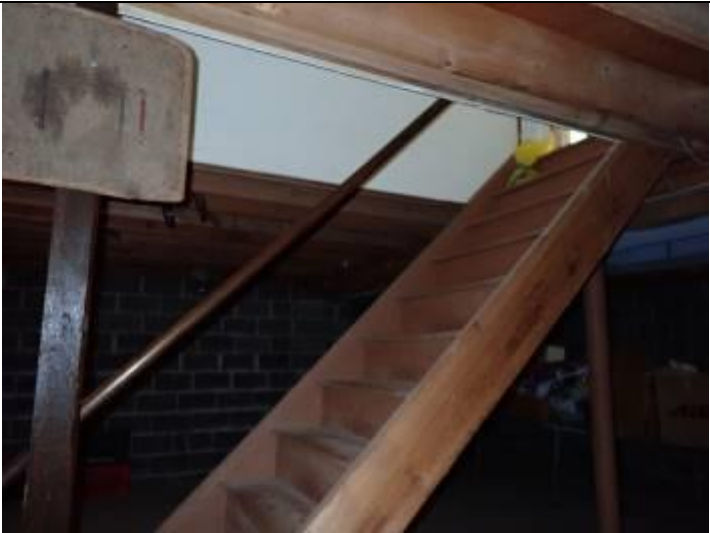
We advise safety balusters at the open basement stairs.

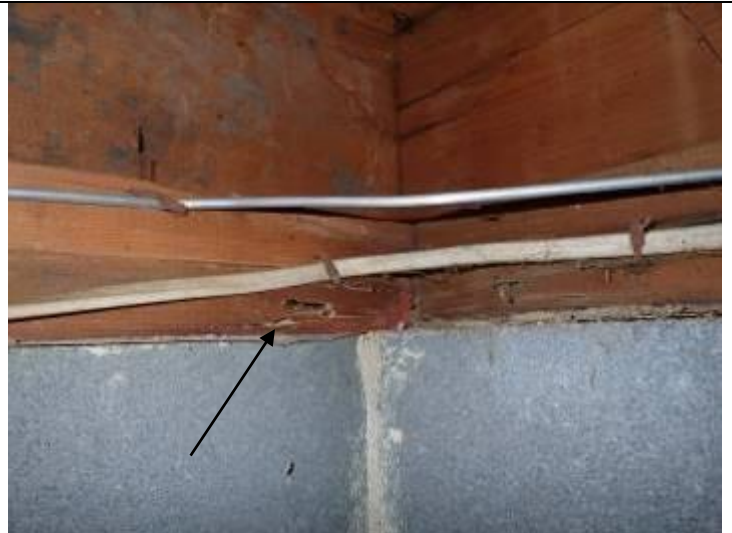
Termite damaged sill along left side basement wall.

3. Damage from wood destroying insects was noted in the following area(s): __
 Termite damaged sill in basement.

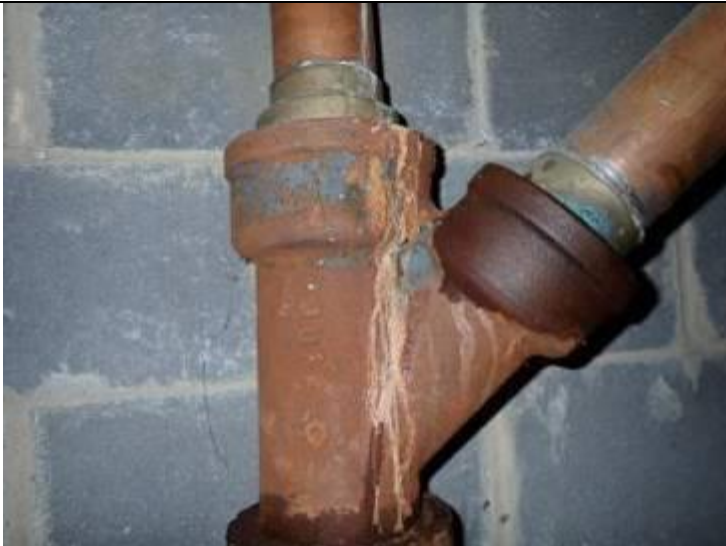
Old cast iron waste lines are corroded. Eventual replacement is advised.

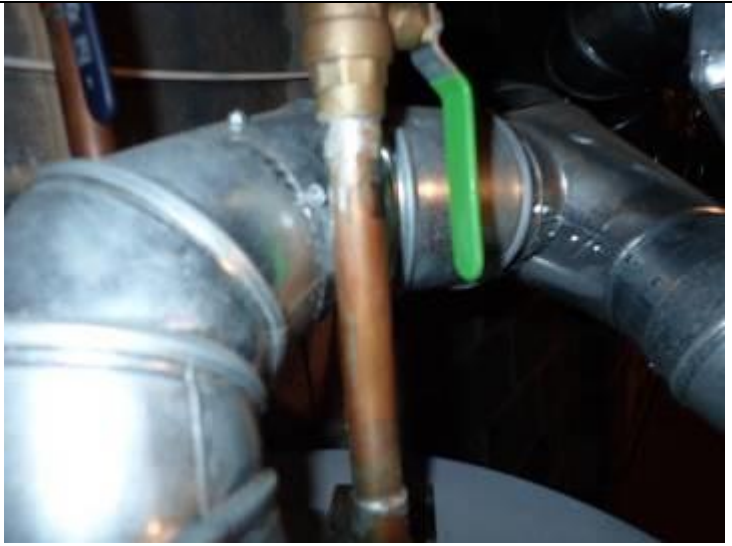
Comments: Eliminate contact between water heater vent (steel) and water lines (copper). Dissimilar metal contact promotes corrosion. Average design life expectancy for water heaters is **8-14** years.

Steel vent and copper line should not be in contact. This at water heater.

Eliminate contact between water heater vent (steel) and water lines (copper). Dissimilar metal contact promotes corrosion.

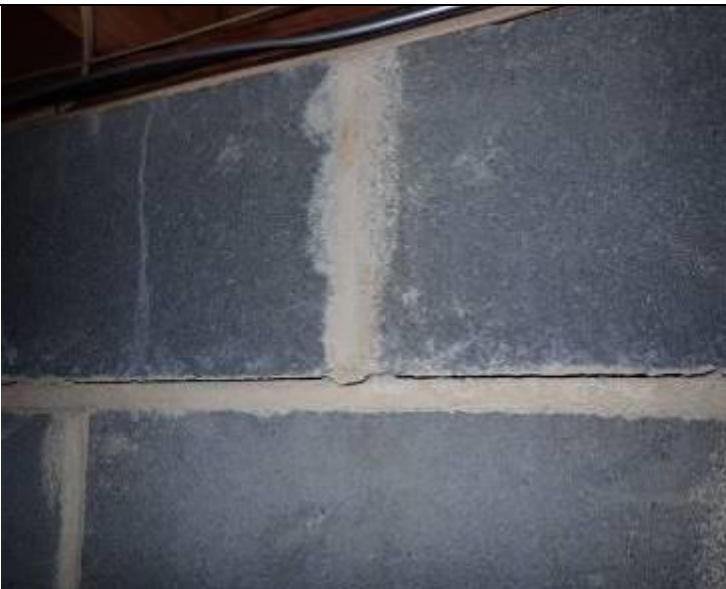
Horizontal hinge crack noted along front basement wall.

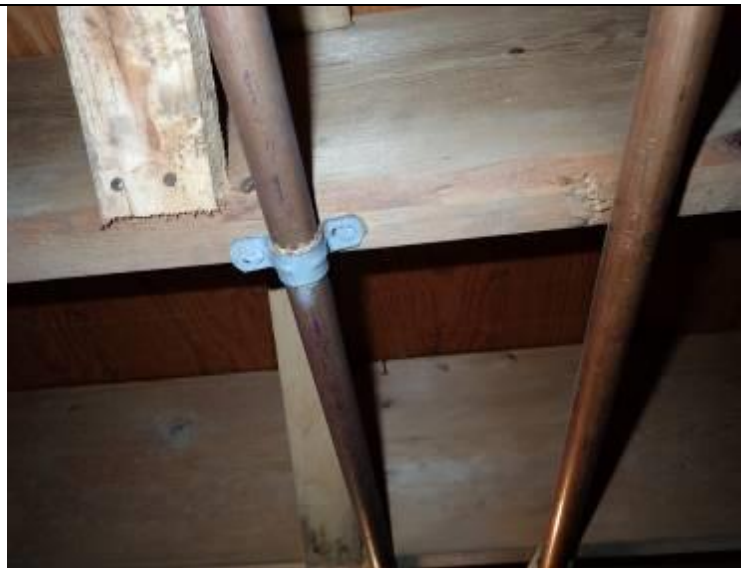
Steel brackets should not be used to support copper water lines. Corrosion is accelerated.

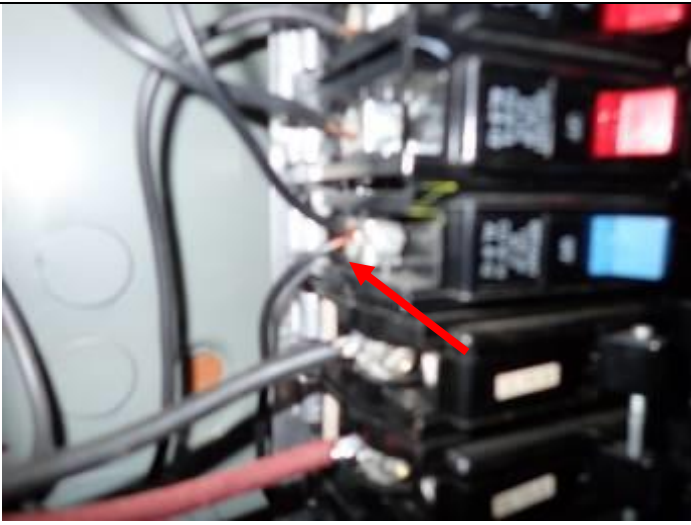
Eliminate double tapped breakers in the electric panel. We advise a single branch wire per breaker.

Electric - We recommend gfci protection for kitchen countertop, bathrooms, garage and exterior electric outlets. Eliminate double tapped breakers in the electric panel. We advise a single branch wire per breaker. We advise filler blanks for empty breaker slots in the electric panel. Make all lights operable. We recommend replacing painted over outlets

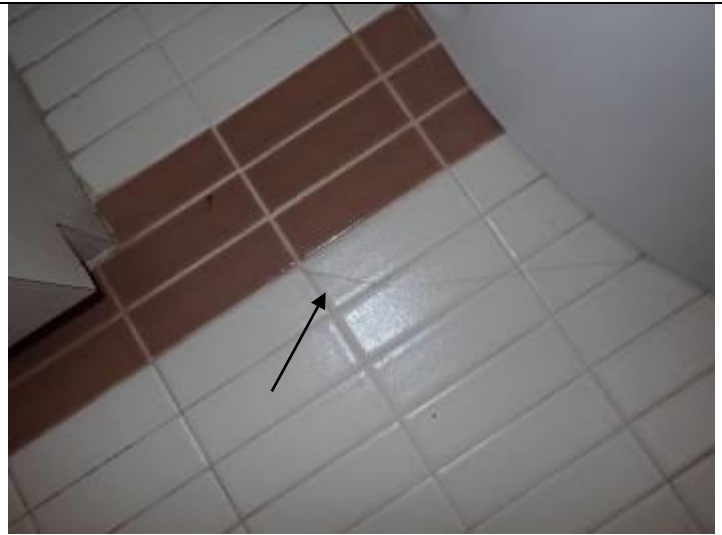
Cracked bathroom floor tile.

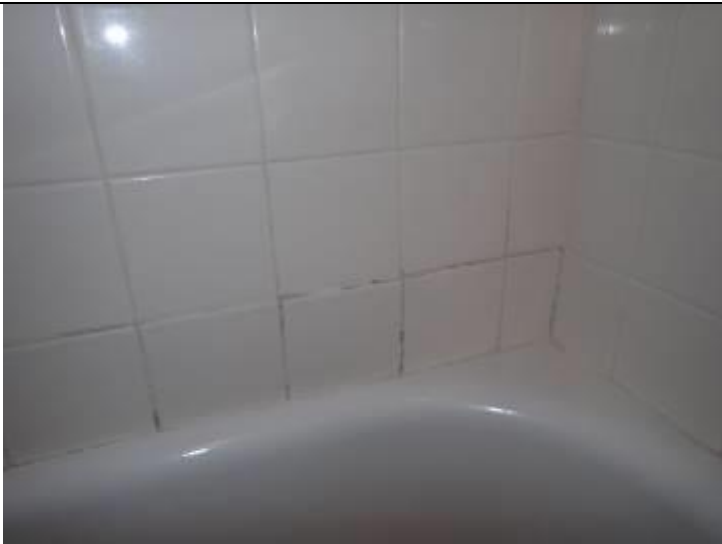
Loose wall tile at the guest shower.

Repair/replace loose wall tile at the guest shower. We note peeling wall paper in the fireplace room. Stained ceilings are noted in the den, hallway, closets and cracked ceiling in the fireplace room. Correct the source of the staining and replace damaged materials. We note cracked floor tiles at the guest bathroom. We note areas of stained carpeting and squeaky floors.

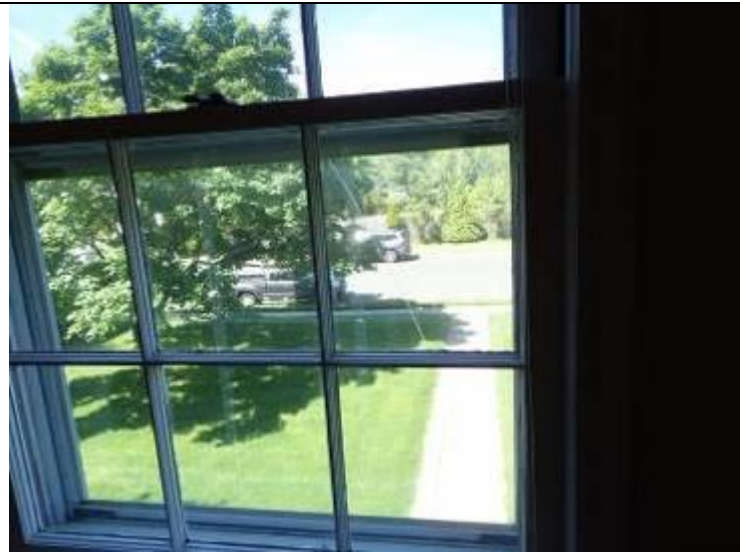
Cracked front storm window.

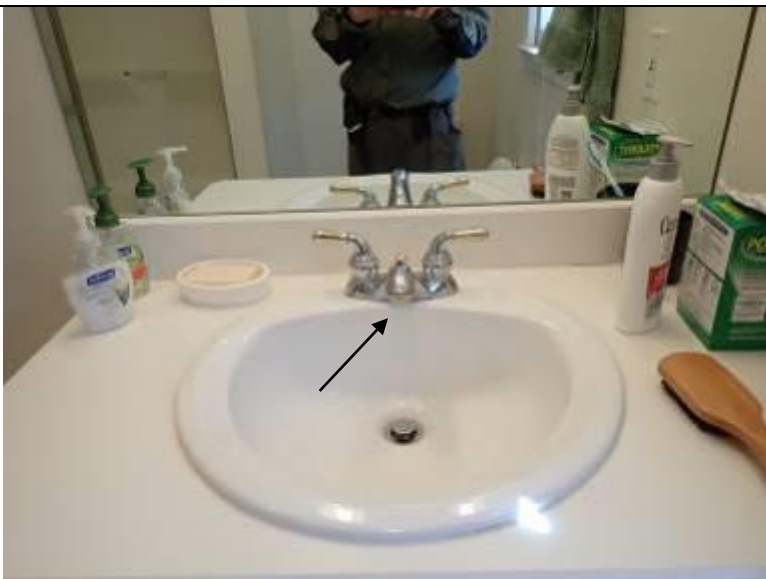
Dripping master faucet.

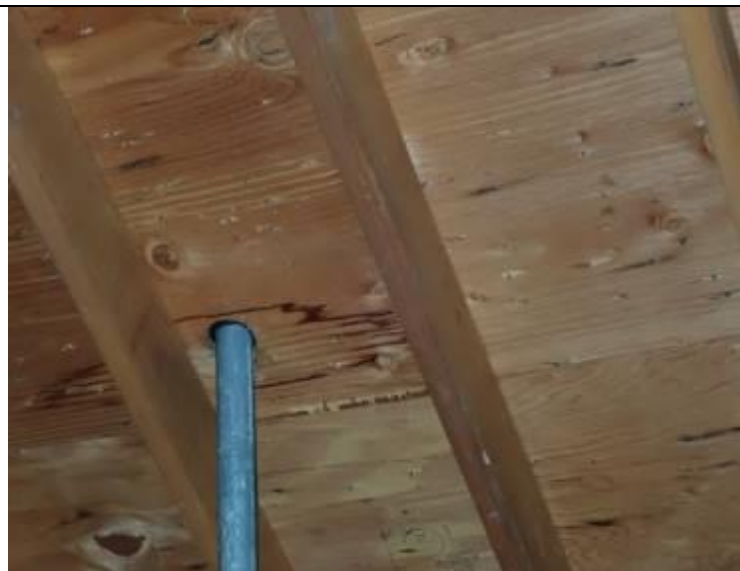
Comments: Staining is noted at sub-roofing in attic adjacent to plumbing vent roof penetration. Have roofer check for leakage. See pictures.

Staining noted at sub-roofing in attic adjacent to plumbing vent roof penetration.

Staining is noted at sub-roofing in attic adjacent to plumbing vent roof penetration. Have roofer check for leakage.
