## HOUSE CHECK HOME INSPECTION LLC

### Confidential Property Inspection Report

INSPECTION ADDRESS: 123 Elm Street  
Fairtown NJ 07777

Property Inspection Date: 5/05/05

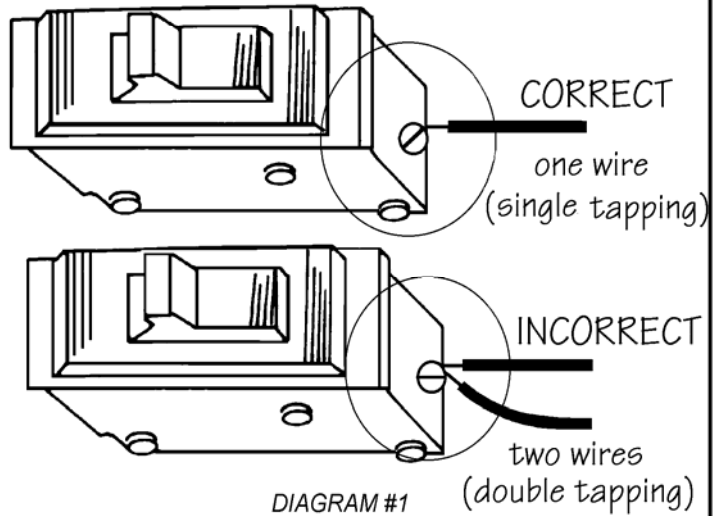
**DOUBLE TAPPED CIRCUIT BREAKERS**

Comments: We recommend installation of Ground Fault Circuit Interrupter outlets (GFCI) for safety considerations at the bar sink. See diagrams. There are double tapped circuit breakers in the service panel. This is improper. Each circuit must have its own breaker or fuse. Install an additional circuit breaker for each double tapped circuit. See Diagram #1.

More than one wire per circuit breaker can cause overloads

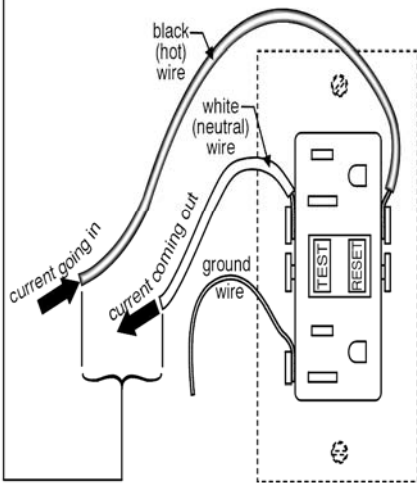
**Ground fault interrupter Outlets within 5 feet of a water source should be gfci.**

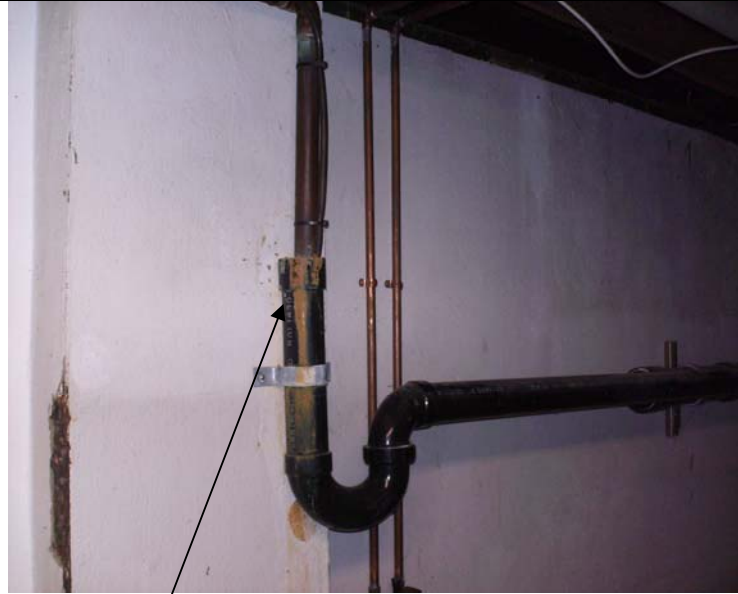
Comments: We recommend cellulose based materials (paneling, sheetrock) avoid direct contact with masonry. They can extract moisture from the masonry and create conditions favorable for micro-bacterial growth. The sump pump discharges into the sanitary sewer. This is improper. The sump pump discharge should to the exterior of the home a minimum of 10 feet. Correction is advised. Use a dehumidifier particularly in warm weather seasons to help prevent dampness, odor, condensation and mold growth in basement.

The basement sump pump discharges into the sewer. This is improper. The sump should discharge to the exterior of the home.

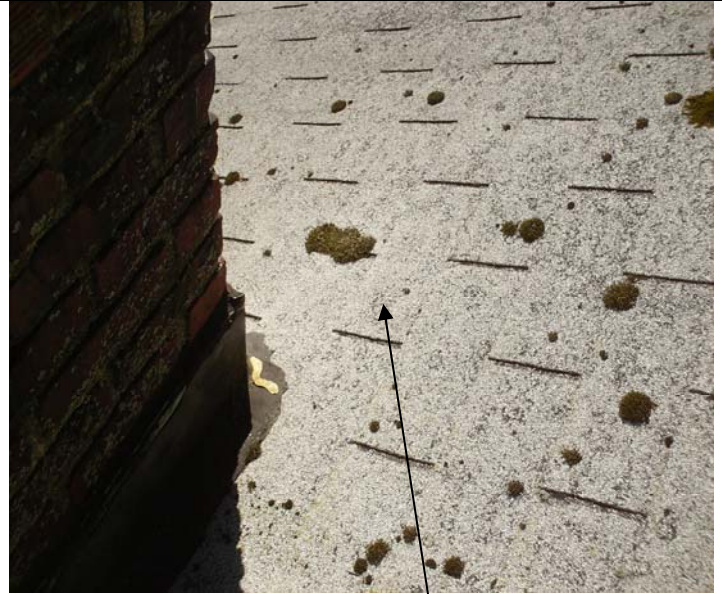
We recommend replacing the worn deteriorated roof shingles.

**Roofing:** Design Life Expectancy: Near \_\_\_ At  Past \_\_\_  
Satisfactory Unsatisfactory   See comments in report  
Necessary repairs are: Replace damaged roof shingles.

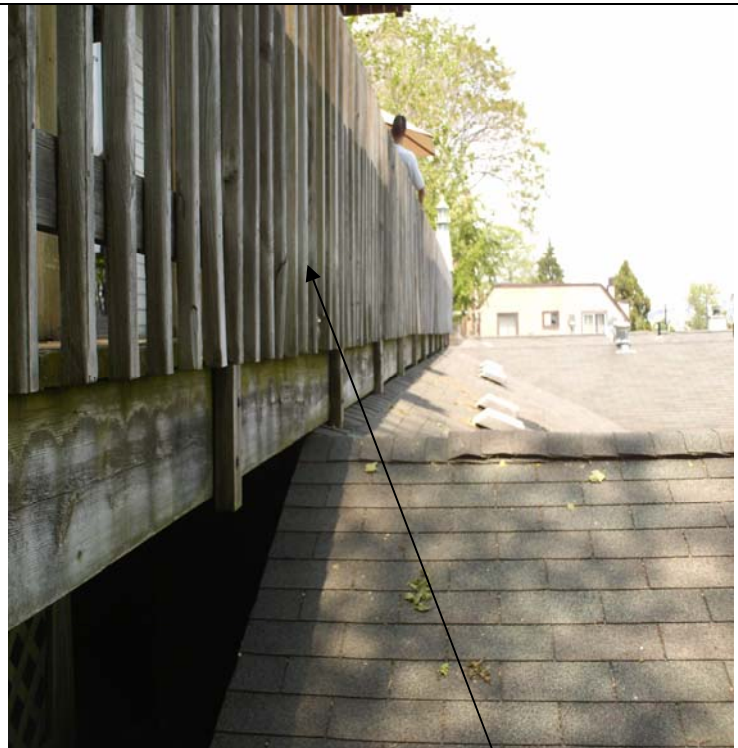
Secure the loose rear deck safety railing.

Comments: We suggest bolting the rear wood deck to the house structure as opposed to nailing for a more secure connection. Vertical 4 x 4 support posts should have proper concrete footings to a depth of 24 inches. Secure the wobbly safety railing and reduce baluster spacing to a maximum of 4 inches. See diagrams and pictures.

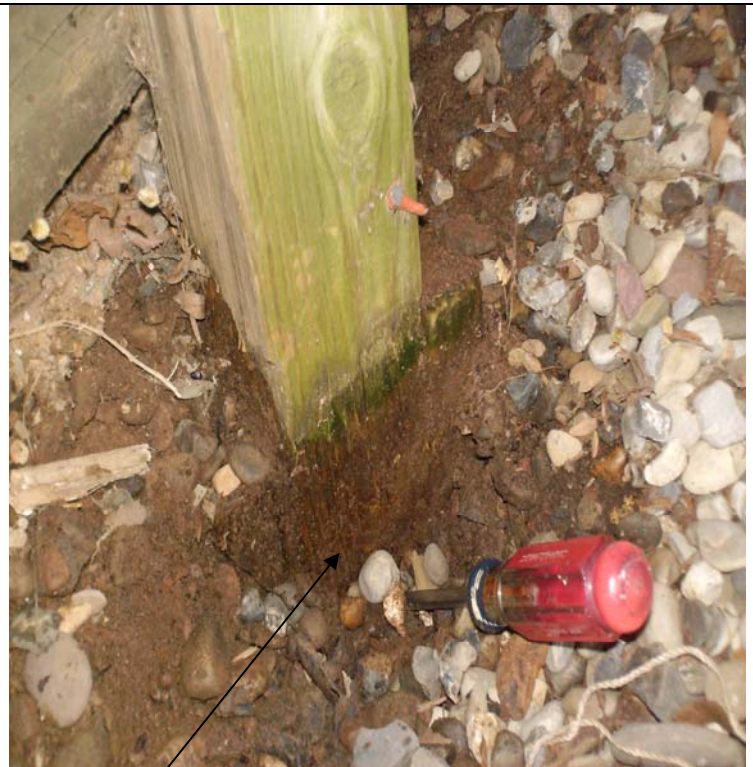
Install proper footings for the deck support posts.
